TECHNICAL NOTE 3847

FATIGUE-CRACK-PROPAGATION AND RESIDUAL-STATIC-STRENGTH
RESULTS ON FULL-SCALE TRANSPORT-AIRPLANE WINGS

By Richard E. Whaley, M. J. McGuigan, Jr.,
and D. F. Bryan

December 1956

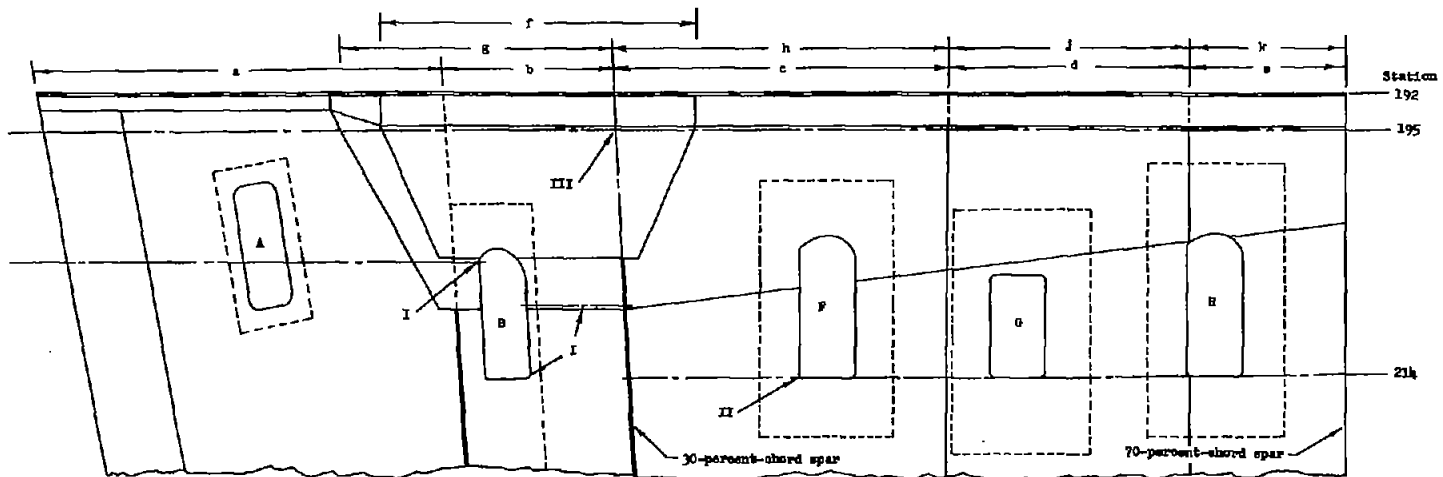
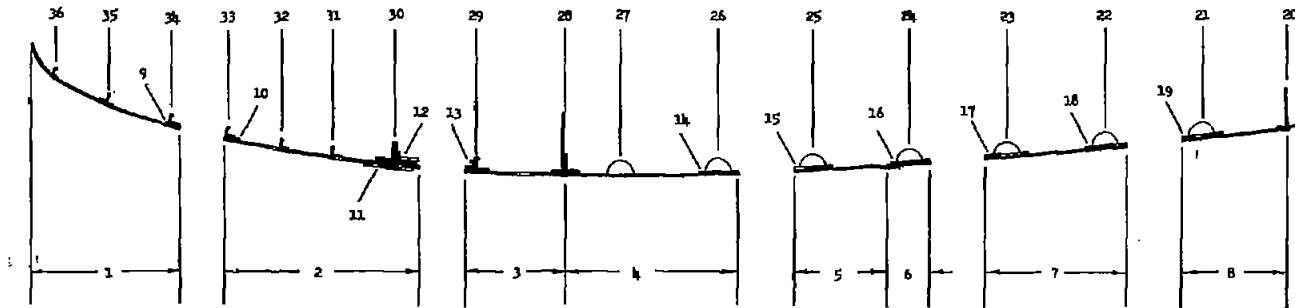
Figure 2.- Details of wing structure and location of failures.

General description of cracks.- All the fatigue cracks that grew until their respective propagation curves indicated that the wing would fail if the test were continued are listed in table II. The cracks occurred at three different locations which are indicated in figure 2 and can be described generally as follows:

Area	Location	Span station
I	Vicinity of cutout B	214
II	Corner of cutout F	214
III	Joggle in doubler	195

Of the 17 cracks reported here, 12 originated in area I, 3 in area II, 1 in area III, and 1 in a machined notch. Nine of the 12 cracks that originated in area I initiated at the edge of the external doubler plate between the 30-percent-chord spar and cutout B. The other three initiated only a few inches away at the outboard rear corner of cutout B. A small crack sometimes originated in the doubler (element 11) in the forward inboard corner of cutout B. This crack never grew until another crack originating in area I progressed to it so both were considered to be in area I. All these cracks progressed through the same elements in approximately the same order.

Elements 1 to 8 apply to skin at span station 214.
 Elements 9 to 19 apply to doublers at span station 214.
 Elements 20 to 36 apply to stiffeners at all stations.
 Elements a to e apply to skin at span station 195.
 Elements f to h apply to doublers at span station 195.
 I, II, and III apply to the three failure areas.

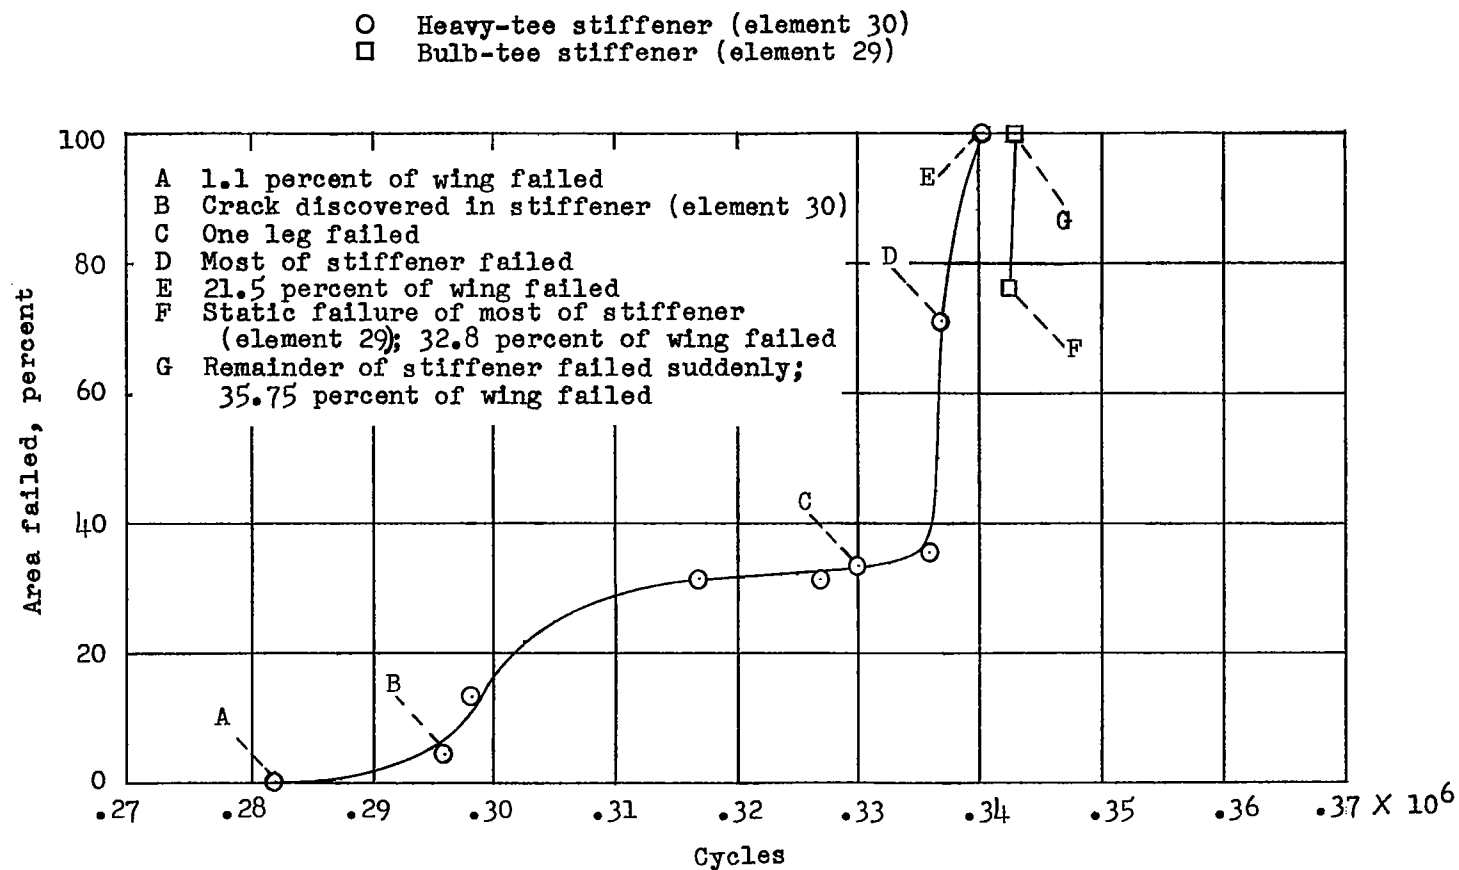
(b) Crack 15; $\Delta n = 0.625$.

Another propagation curve similar to the propagation curves of the entire wing structure was obtained from another element. This curve is shown in figure 9(b). This element is the heavy tee stiffener (element 30). Although the load level Δn of the test was 0.625, the rate of progress of the crack was slow. One reason for this was that element 30 had a larger area than any other element in the wing and started to fail when the wing had a little more than 1 percent of the entire area failed. The most noticeable difference between this curve and the wing propagation curves was that the critical point occurred at about 35 percent of the area of the element. That point corresponded with the critical point for the whole wing at which time 5.8 percent of the wing tension area was failed. The shape of these stiffener propagation curves depends on the alternating load level and the increase in stress in the stiffener during the test. The failure of the surrounding material causes more load to be added progressively to the stiffener and thus increases the stress. Since the cracks progress through the elements in slightly different orders in each wing, the stiffener propagation curves are subject to some variation.

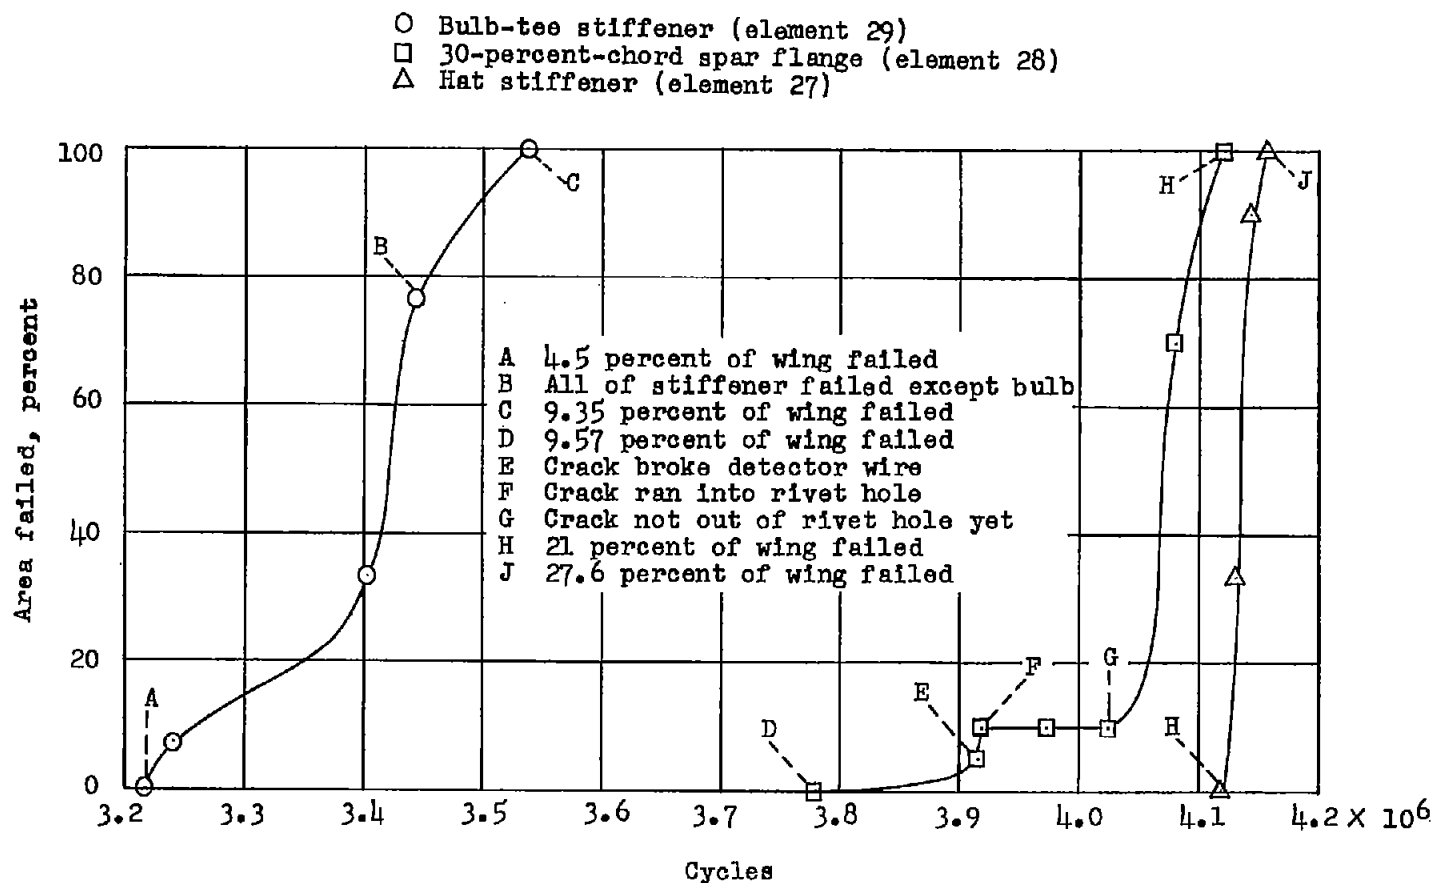
(e) Crack 1; $\Delta n = 0.250$.

A crack-propagation curve similar to the crack-propagation curves of the entire wing structure was obtained from the failure of one of the spar flanges (element 28). This curve is shown in figure 9(e). The element was from a wing tested at the lowest load level so that the maximum stress in the element was lower than that in any other of the wings

tested. A fatigue crack was detected by a crack detector wire (indicated by the letter E) when only about 5 percent of the element was failed. The crack then progressed to a rivet hole which slowed the progress of the crack. The curve then exhibited a critical point where the growth of the crack became rapid. This critical point occurred at about 10 percent of the area of the element, which agrees with the percentage at the critical point for the entire wing structure at this load level.

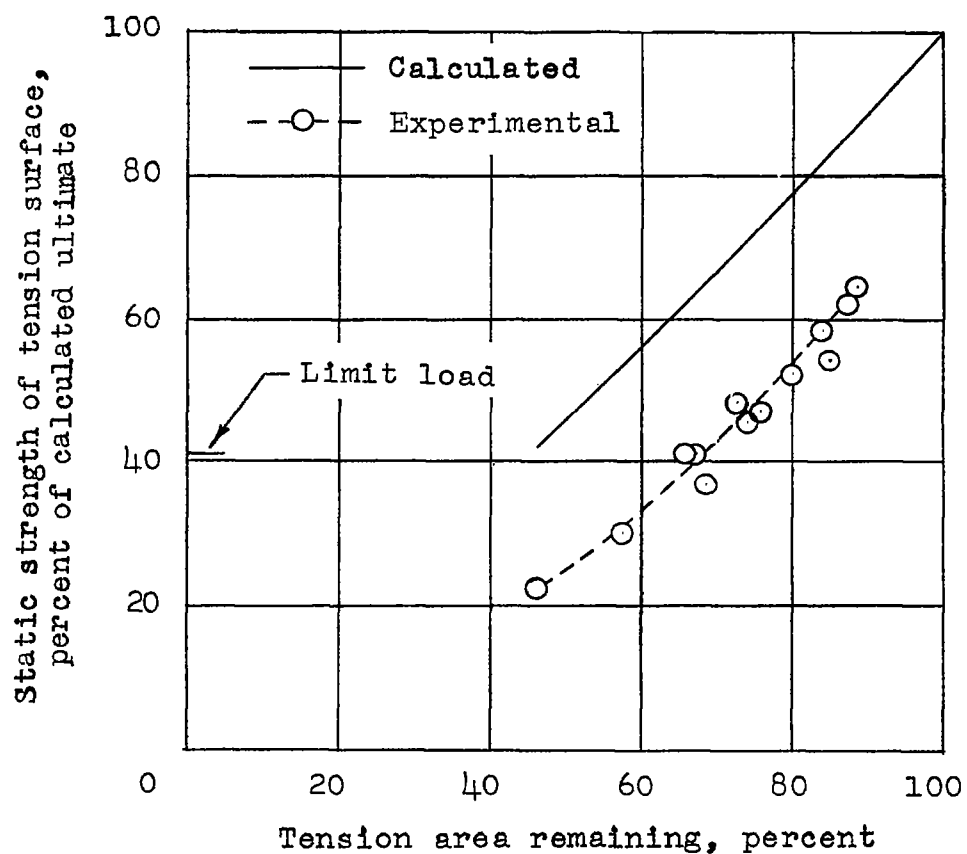
Figure 13.- Residual static strength of tension surface of C-46 wing.

This reduction in strength is shown clearly in figure 13 in which the static strength of the tension surface of the wing is plotted against the percent of cross-sectional tension area remaining in the wing. The solid line in figure 13 shows the relationship between the calculated strength of the tension surface and the tension area remaining after fatigue failure. The calculated strength is based on the reduced section properties of the wing after the fatigue test. Structural analysis of the wing indicated the strength of the tension surface of an undamaged wing to be about 40 percent greater than that of the compression surface for positive bending loads. The calculations indicated that if the compression surface did not buckle the strength of the tension surface would be 7.49g. This value was therefore used as the calculated static strength of an undamaged tension surface, and the actual static strengths obtained from the tests are plotted as a percentage of this figure. No static-strength reduction factor due to holes or cutouts was used in this calculation.

It can be seen in figure 13 that the actual strength is less than the calculated strength by about the same amount throughout the range of the test values. This reduction amounts to about 23 percent of the static strength of an undamaged wing. This reduction in strength can also be expressed as a static-strength reduction factor which is defined here as the ratio between the calculated strength and the actual strength at the same percentage of material remaining. This factor is calculated for each wing and is listed in table III. In figure 14 this static-strength reduction factor is plotted against the percent of tension area remaining in the wing. This figure indicates that as the amount of tension area remaining in the wing decreases the static-strength reduction factor increases. This increase is due to the static strength decreasing while the difference between the calculated strength and the actual strength remains constant. This factor can be used directly along with the calculated strength to find the actual strength.

The residual-static-strength data, figure 13, indicate that the C-46 wing could withstand, without failure, a positive gust which produced a load factor equivalent to the design limit load with as much as 30 percent of the lower cross-sectional area failed in fatigue. Therefore, a considerable length of time should exist in which the crack would be large enough to be easily discovered and during this time the wing could withstand without catastrophic failure any load that the airplane would be likely to encounter.

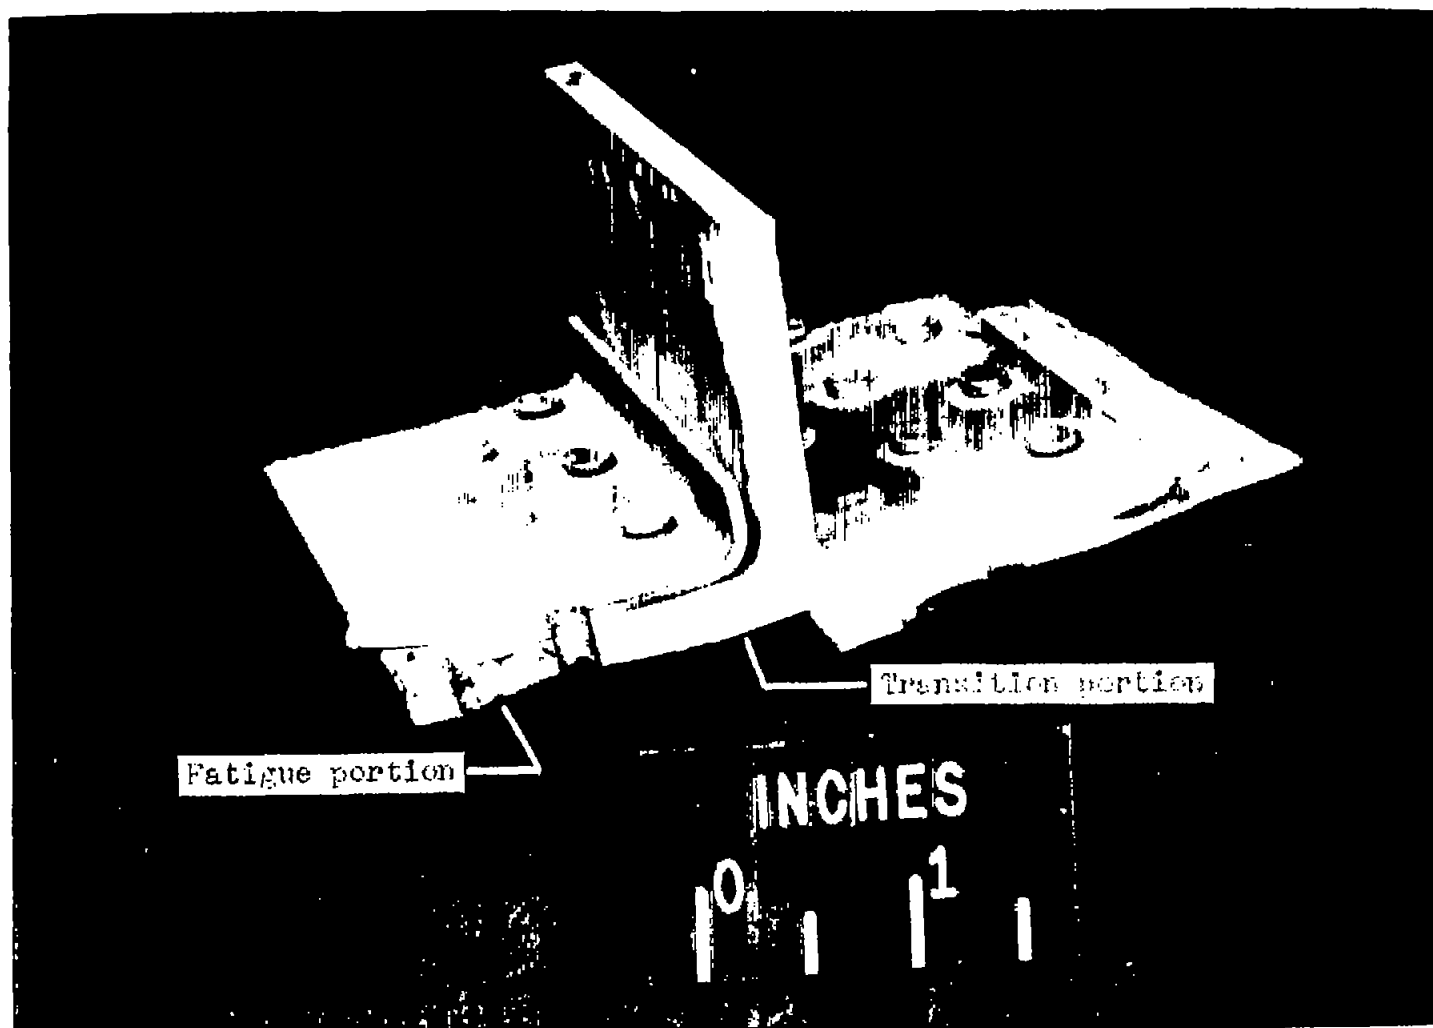
Figure 16.- Typical fractured surface.

Generally, the failure of most of the elements started as a fatigue type and then changed to the transition type. An example of this is shown in figure 16(a). At all load levels after the critical point had been passed, the failures were mostly of the transition type (see fig. 16(b)). For comparative purposes a purely static failure is shown in figure 16(c). Most of the failures did not exhibit all of the identifying characteristics enumerated, and some would be difficult to classify if it were not known beforehand which type of failure had occurred.

(a) Failure starting as fatigue type and changing to transition type. L-90899.1

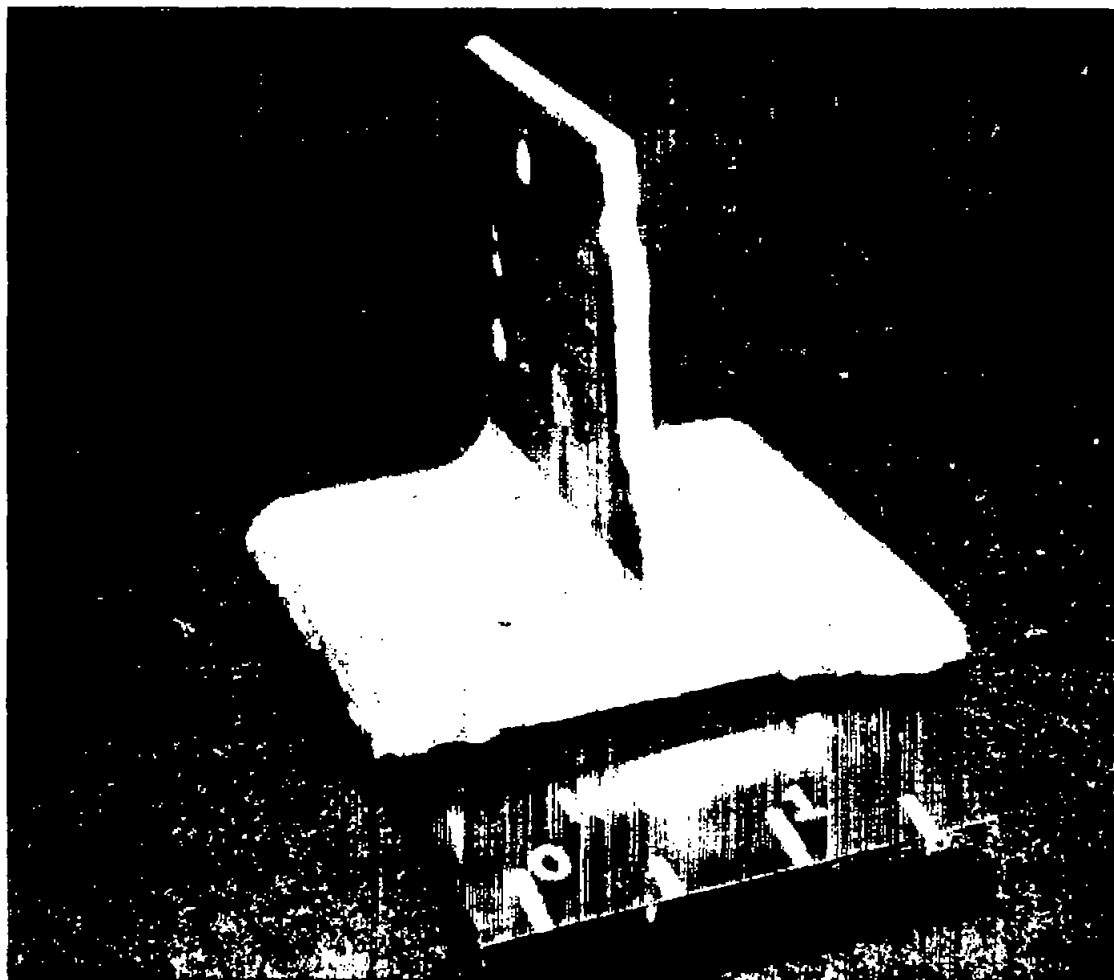
Figure 16.- Continued.

(b) Transition type failure.
